## INVENTORY FORM FOR STATE HISTORIC SITES SURVEY

GIBSON'S GREEN FARM

The farmhouse on Gibson's Green Farm circa 1856 is a two and one-half story three bay by four bay frame three room plan house on Route 213 just north of Cecilton, Maryland. The house faces south with the main gable running on a north/south axis.

CE-964

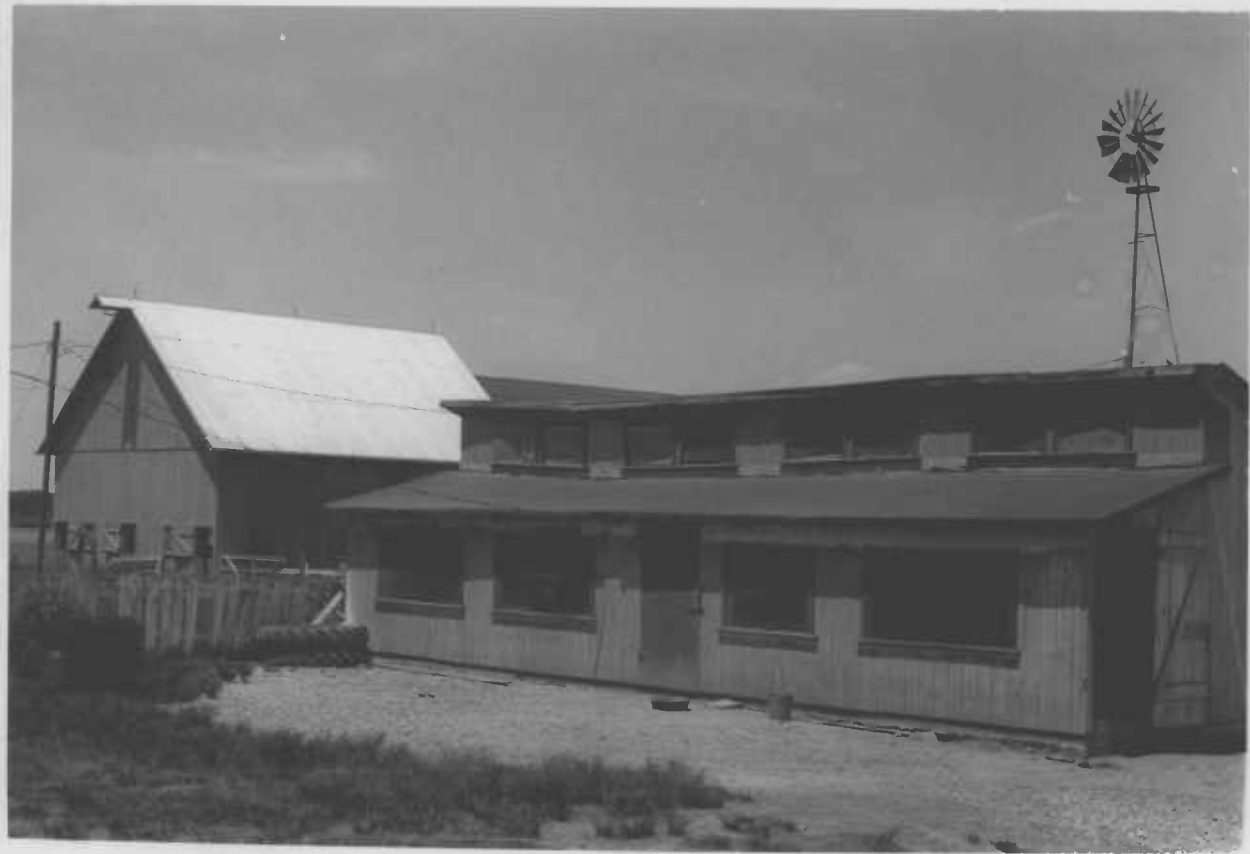
CE-964

A granary is found down the lane to the north of the house and is a typical two story form with side cribs and central passage. Other more recent chicken coops and cow barn are found directly north of the house. An iron windmill is located in the midst of these later structures. Thorn hedge fences line some lanes and according to the owner was the accepted mode of outlining fields and property lines.

GIBSON'S GREEN FARM  
SOUTHERN ELEVATION OF  
CHICKEN HOUSES  
NR CECILTON, MD.
